ORNL-5368

FEASIBILITY OF CITIZEN CONSTRUCTION OF EXPEDIENT FALLOUT SHELTERS

FINAL REPORT

DCPA Work Unit 1637E

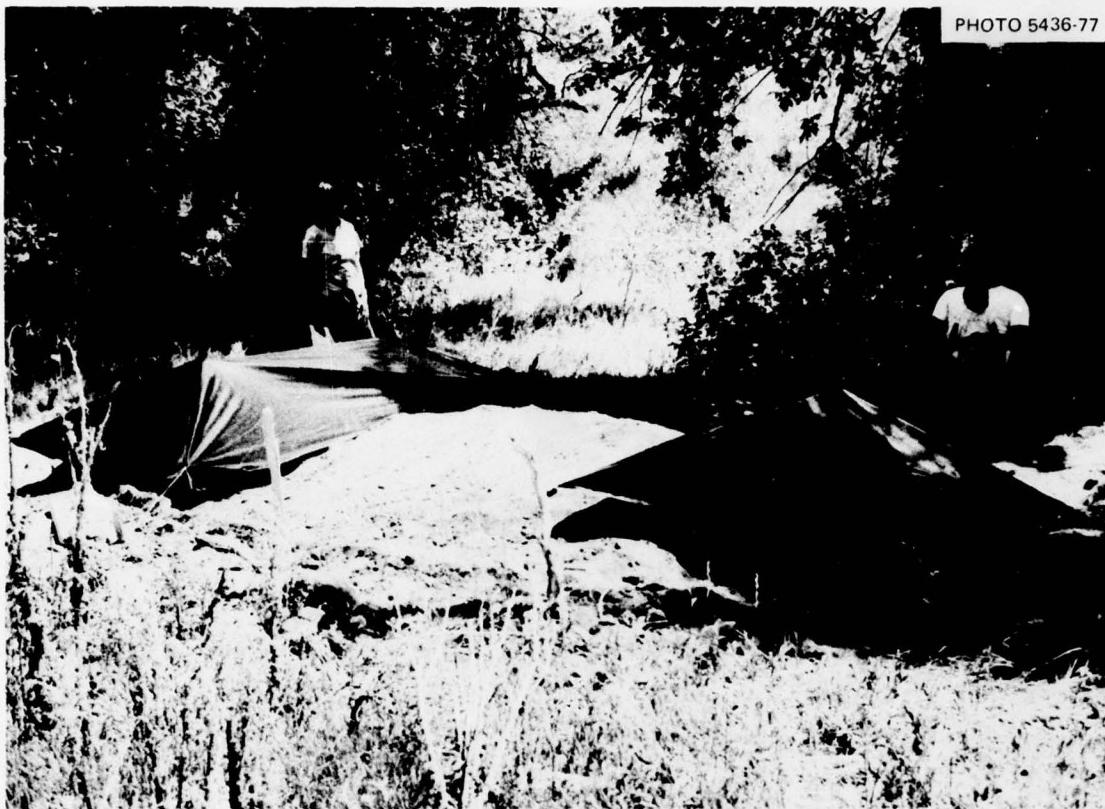
Fig. 4.1. Canopies neatly erected over Door-Covered Trench Shelter entrances. Winds and rainwater later knocked them down.

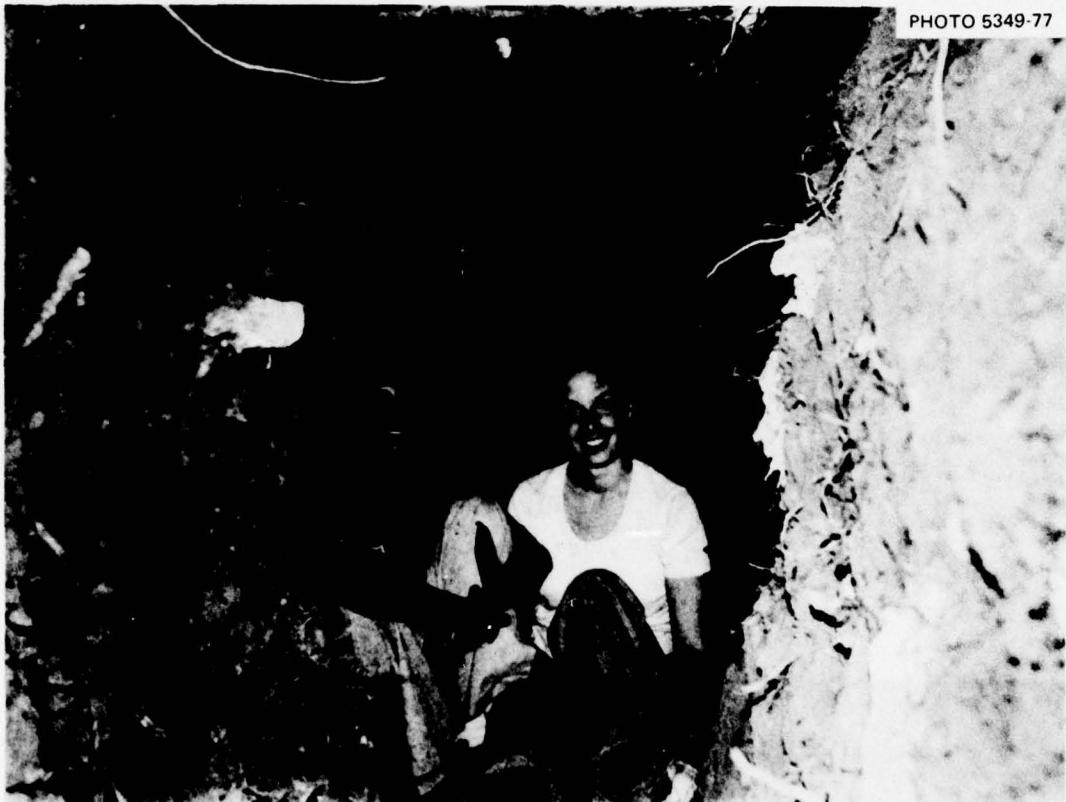
Fig. 4.3. Interior of Log-Covered Trench Shelter. (Note the large tree root system through which the trench was dug.)

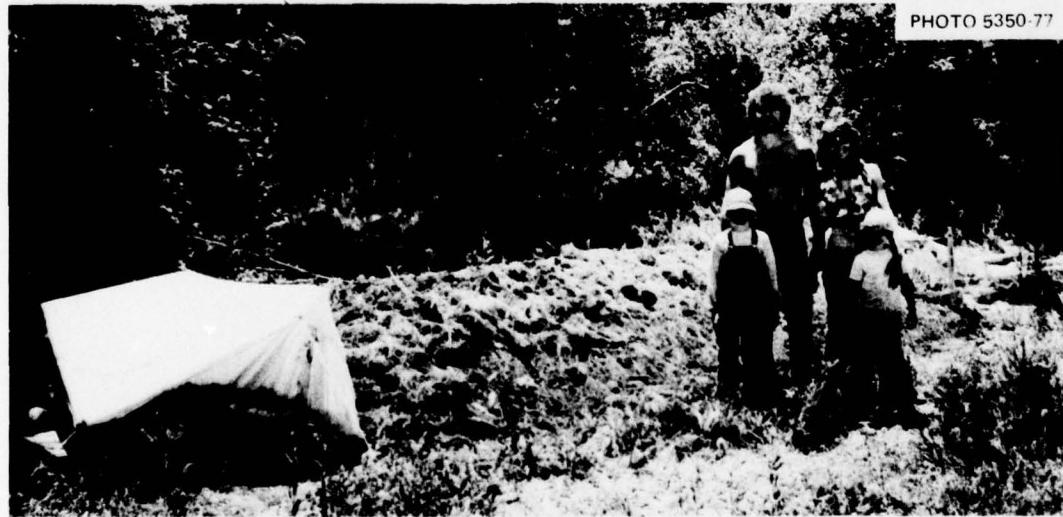
Fig. 4.5. Completed 4-person Log-Covered Trench Shelter. Flimsy canopy over entry is evidence of the need for better instructions and illustrations to enable an average American to make a stable canopy of specified height, with specified openings for adequate ventilation.

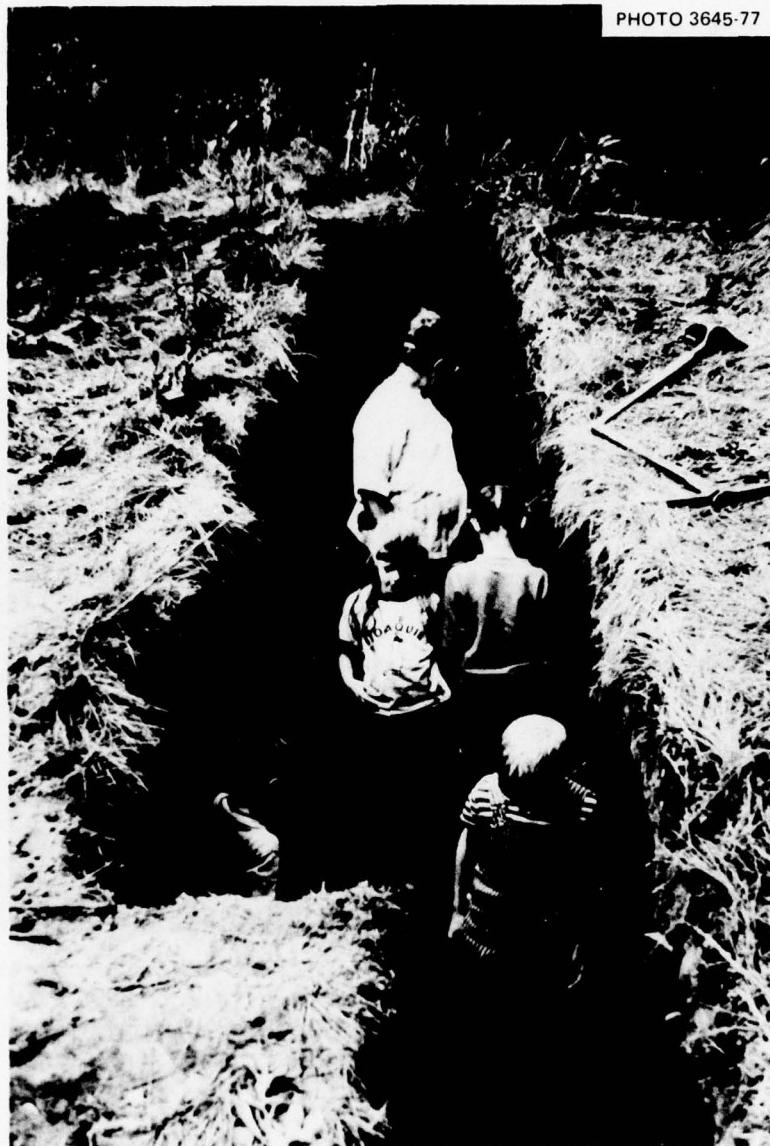
Fig. 4.8. The father interpreted the trench instructions as requiring 2 ft 9 in. per person rather than per adult. Thus the final trench was 22 ft long, perhaps longer than necessary for a family with so many small children.

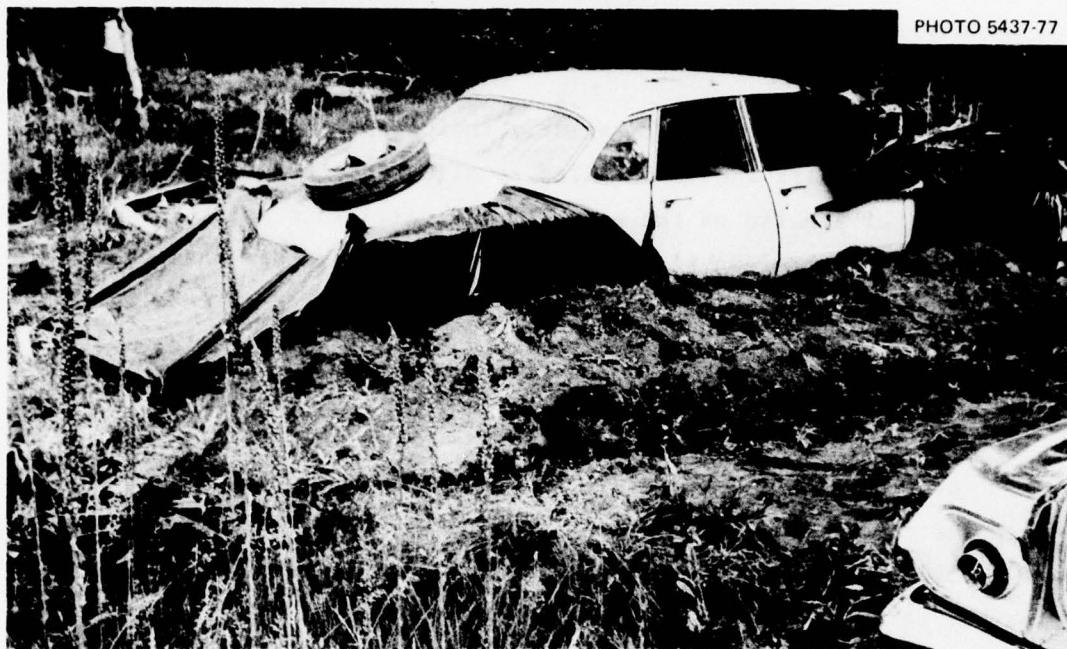
Fig. 4.16. Successfully completed Car-Over-Trench Shelter.

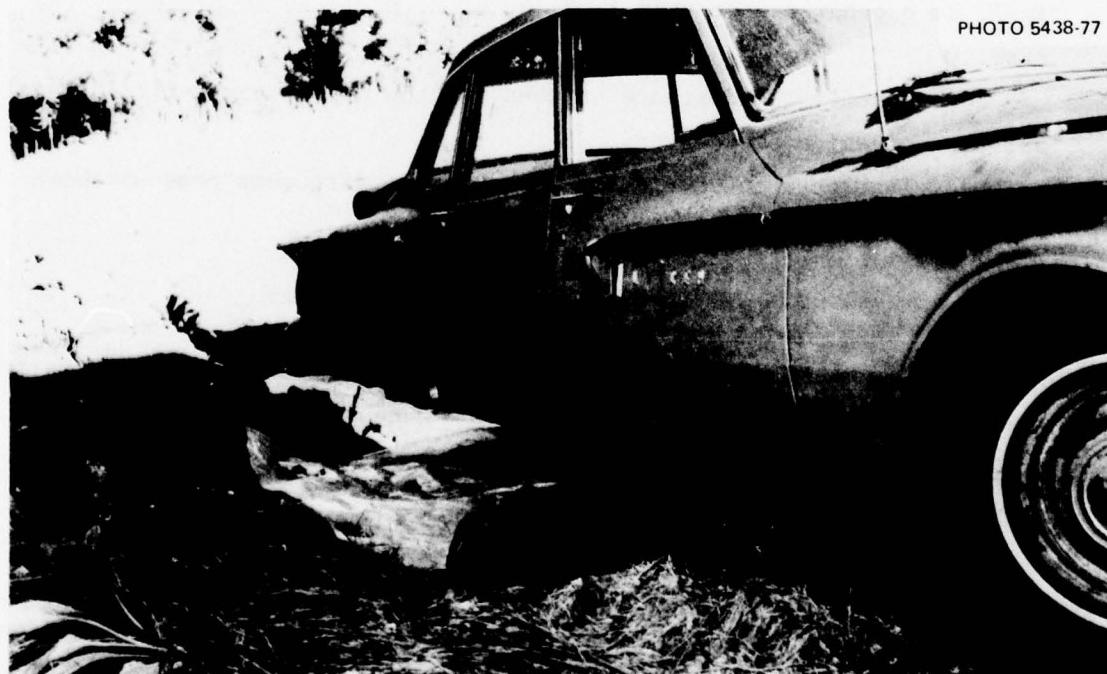
Fig. 4.17. Rear left wheel of car driven too close to side of trench. Left wheel sank into earth, as edge of trench collapsed inward, until frame of car rested on ground.

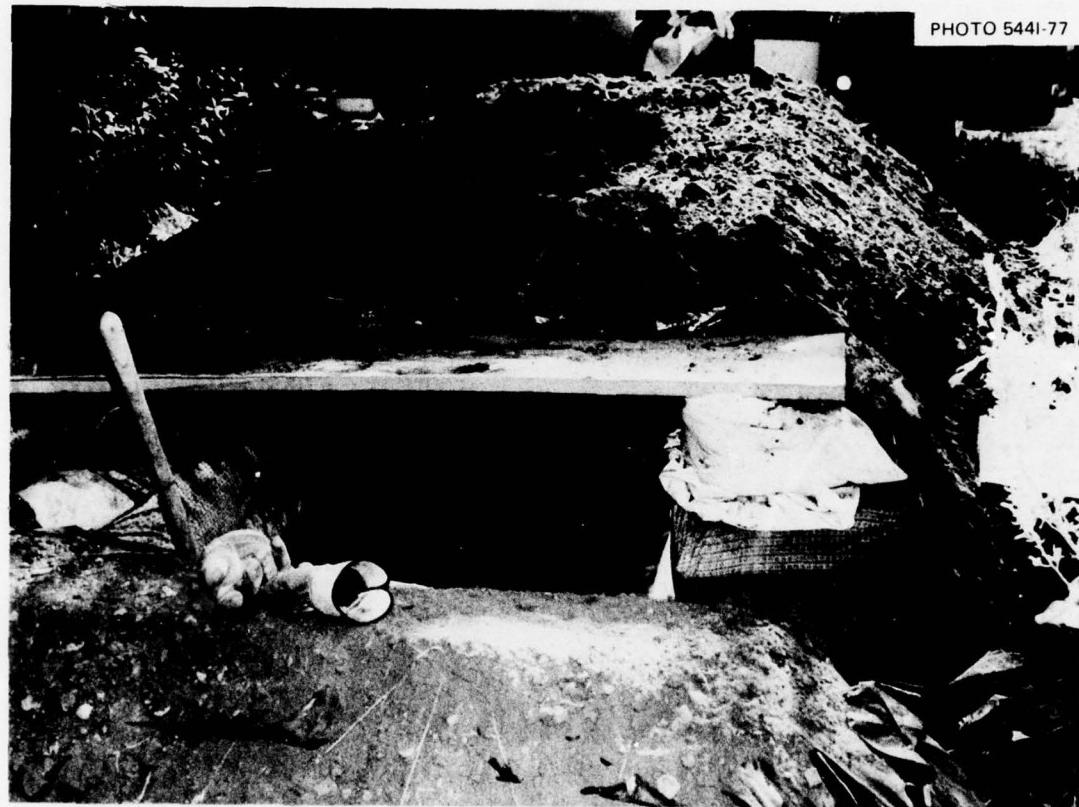
Fig. 4.20. Nearly completed entrance of an Aboveground Door-Covered Shelter. Instructions for making an earth roll over the door, or placing 2 sandbags over the door, should be added.

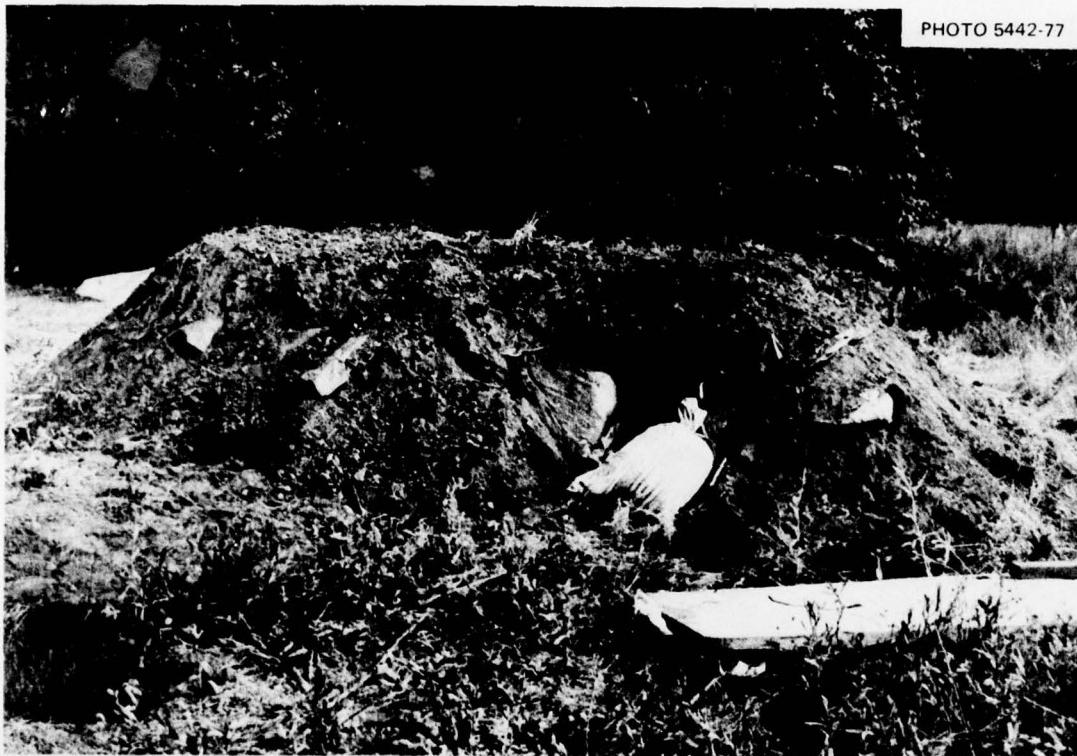
Fig. 4.21. Completed Aboveground Door-Covered Trench Shelter.  
This ground suggested sandbags be placed at side of and above entrance  
before putting earth rolls in place in order to prevent dirt from falling  
into entrance.

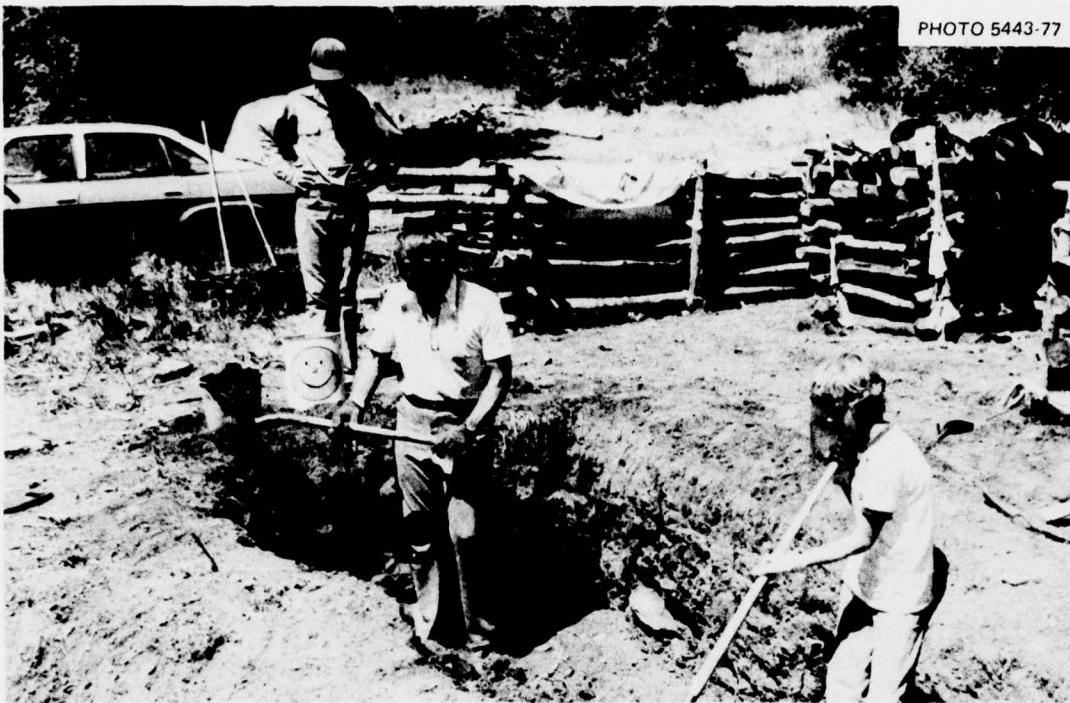
Fig. 4.22. This family, who constructed a Crib-Walled Shelter, discovered that in order to fill the cribs and cover the roof, this aboveground shelter required more digging than many trench-type shelters.

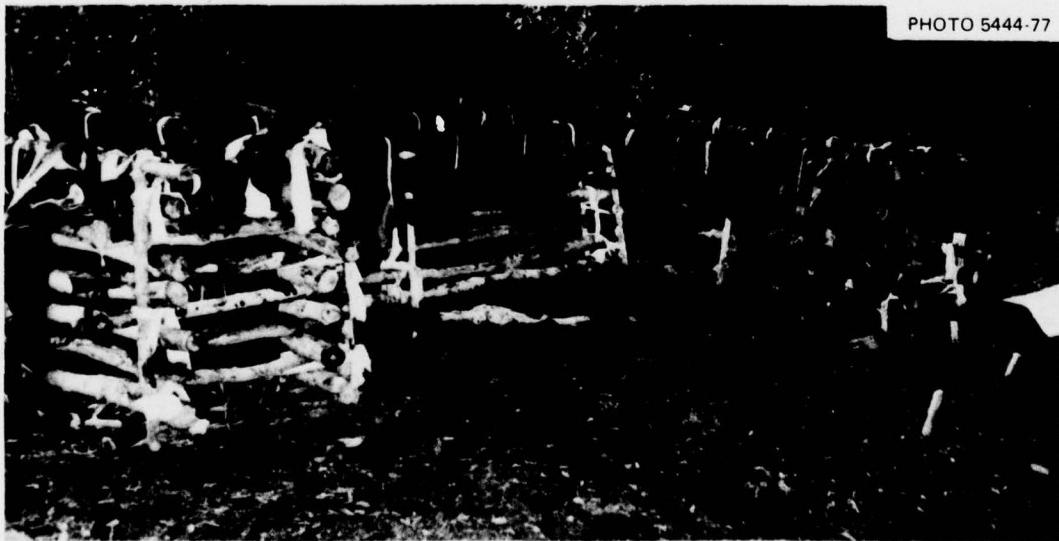
Fig. 4.23. Crib walls which have been lined and are ready to be filled. Note the use of bed-sheet strips used in lieu of rope and wire.

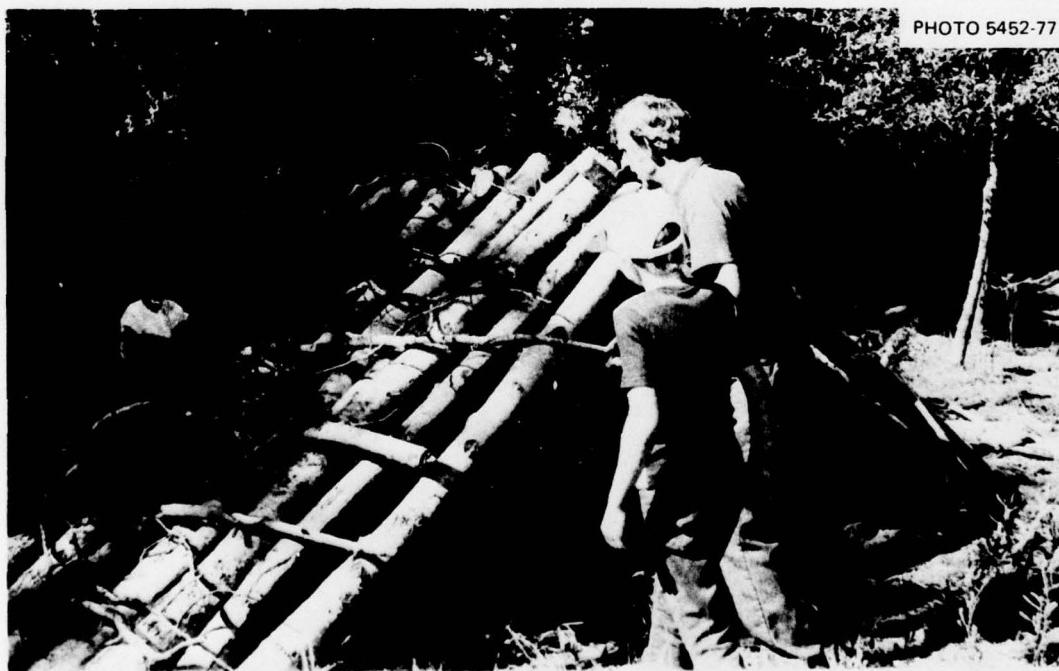
Fig. 4.29. Sticks placed horizontally. More sticks and limbs should have been used, although these few, when covered with 4-mil polyethylene, held the earth covering.

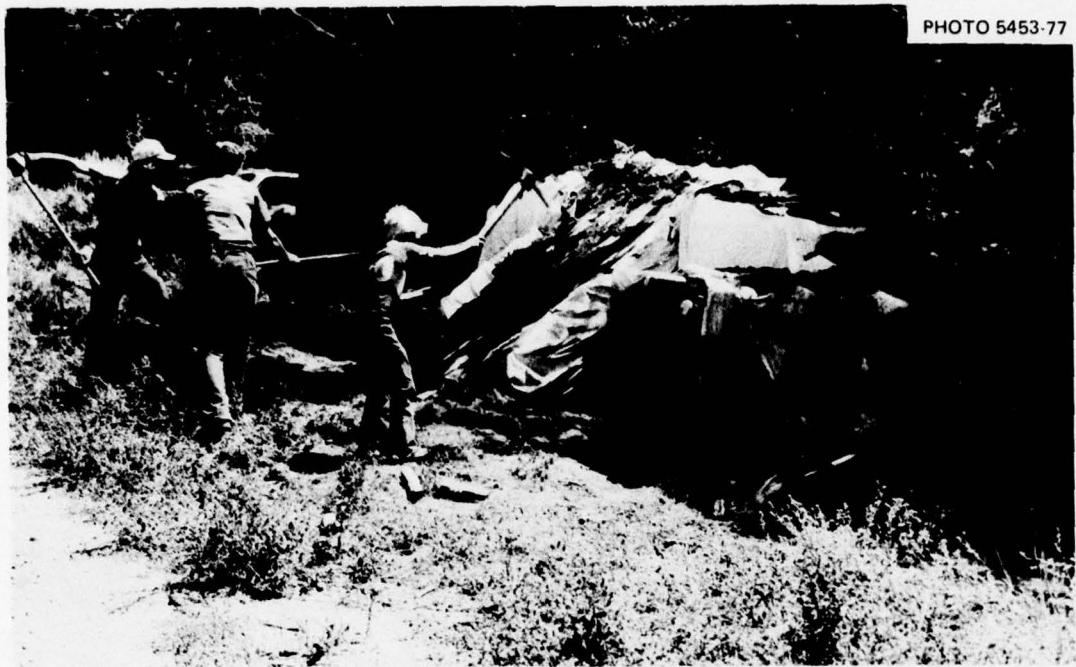
Fig. 4.30. Ridge-Pole Shelter nearing completion. The amount of earth required to cover the structure necessitates locating the shelter in an area where dirt can be easily excavated.

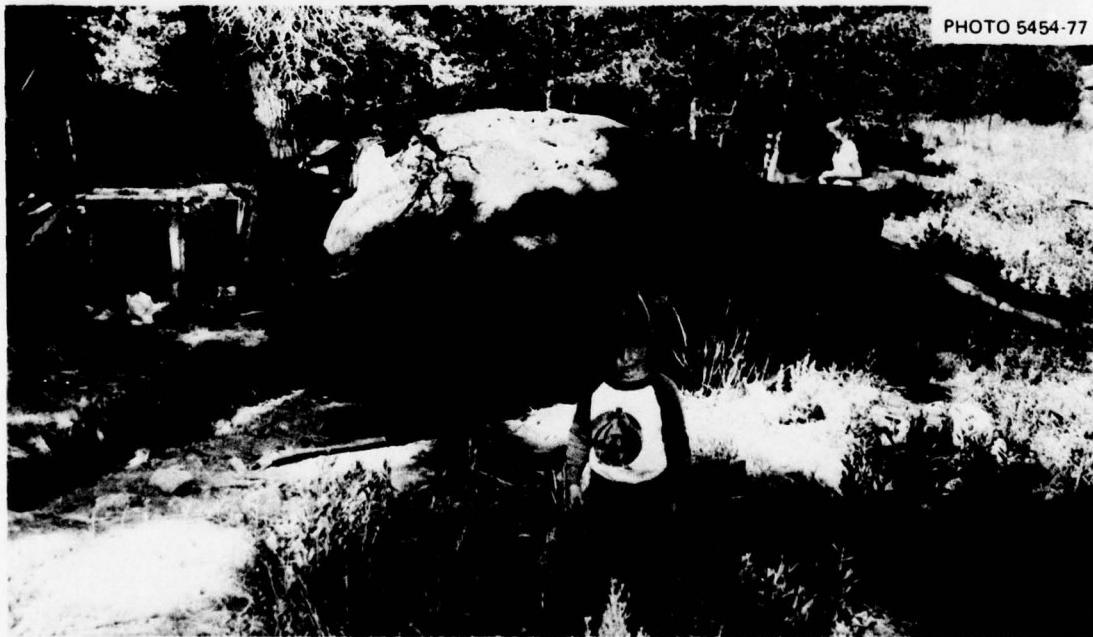
Fig. 4.31. One of the two right-angle entryways of Ridge-Pole Shelter, before being covered with earth.

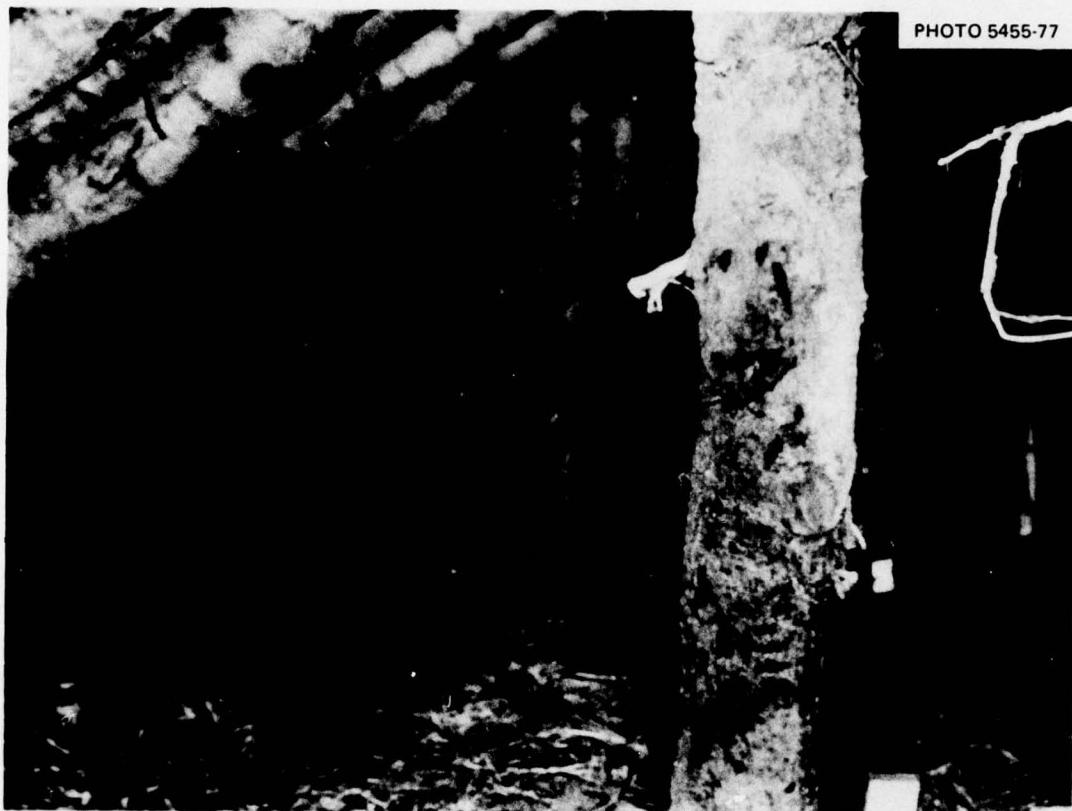
Fig. 4.32. Interior view of Ridge-Pole Shelter.

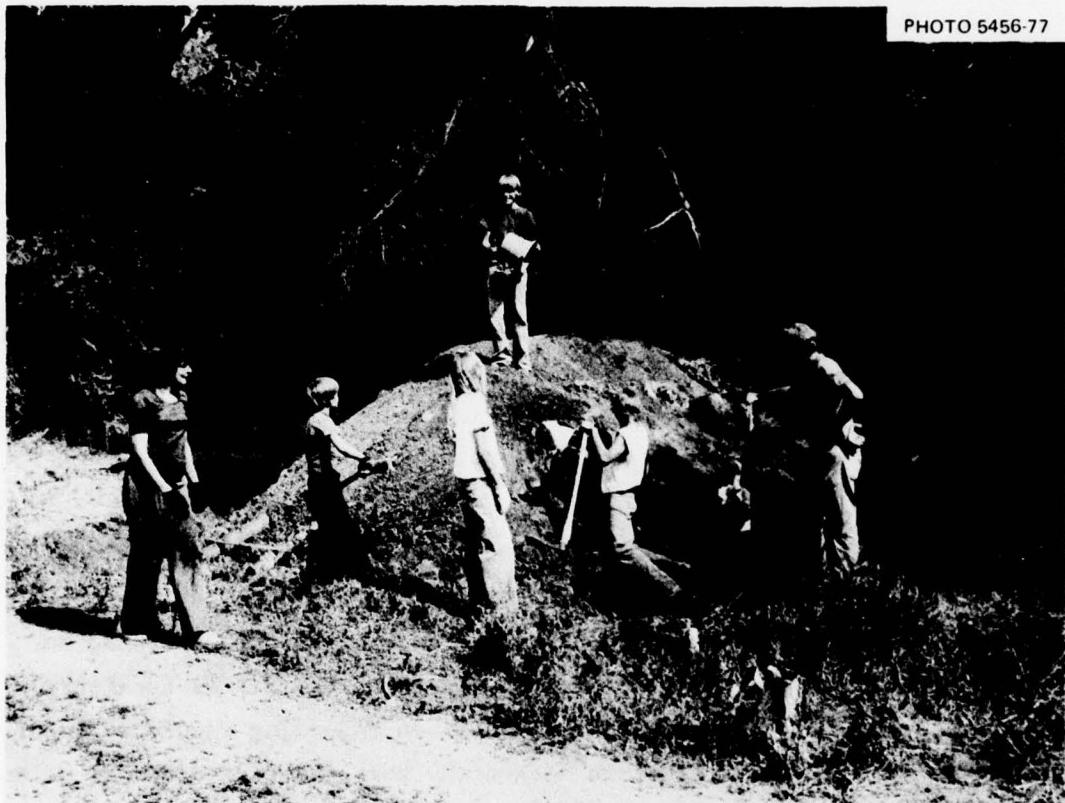
Fig. 4.33. Putting the finishing touches on a Ridge-Pole Shelter.

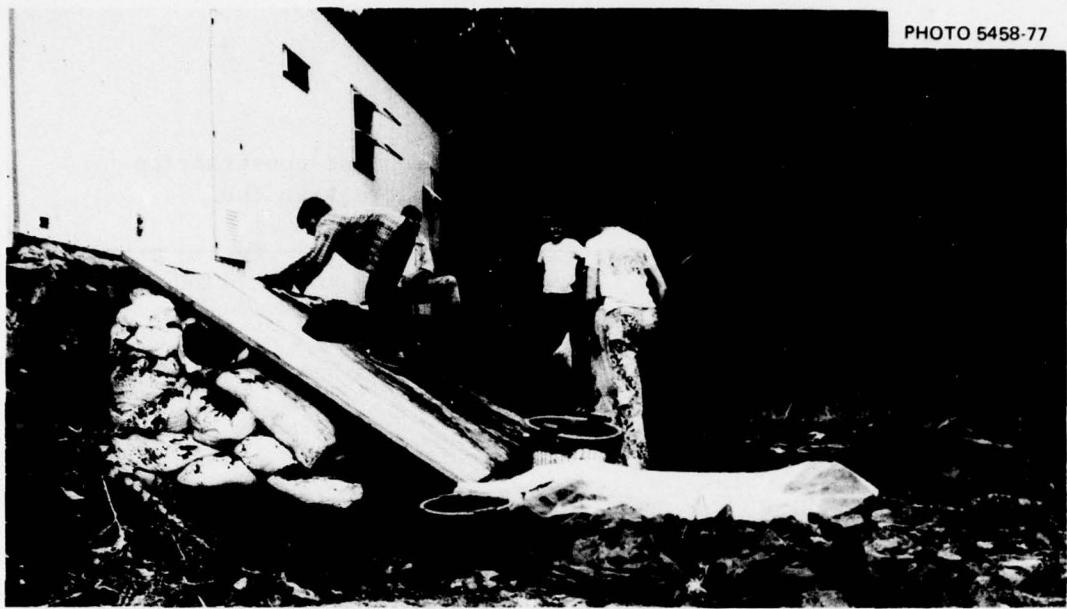
PHOTO 5458-77

Fig. 4.34. End view of Tilt-up Door and Earth Shelter. It was a persistent challenge to keep dirt from sliding down the slanted doors.

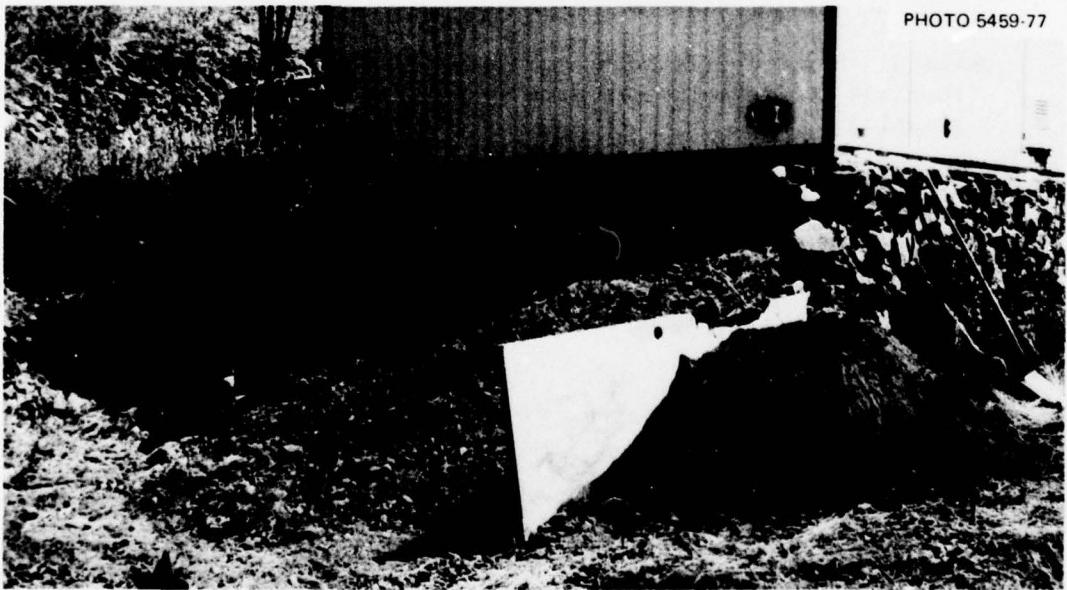
PHOTO 5459-77

Fig. 4.35. Closed end of a smaller Tilt-up Doors and Earth Shelter, built by two young women, indicating a weakness in the instructions. This photo shows a 3-ft-wide thickness of earth piled against the vertical door closing the end of the shelter. The instructions do not make clear that the sloping earth surfaces on both sides of this door should be the same height.

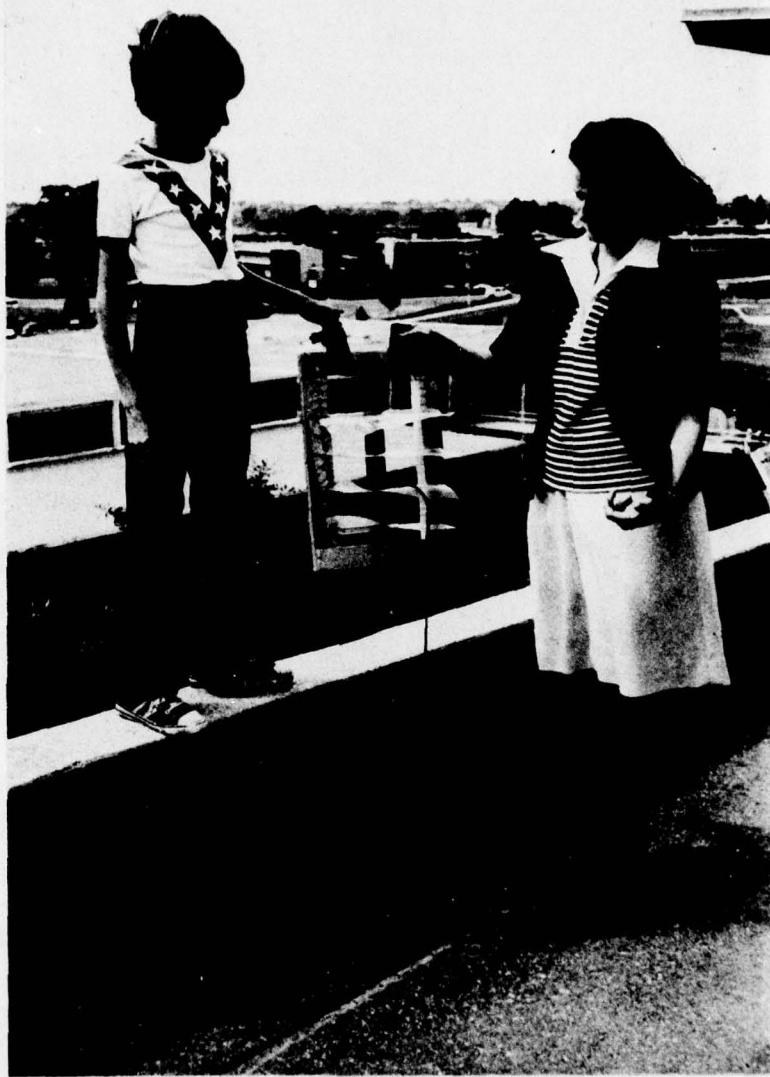
PHOTO 5462-77

Fig. 4.38. The group who constructed this pump interpreted the use of "tacks" in the instructions as referring to thumbtacks. Although thumbtacks were sufficiently strong to secure the thread used for flap stops, they were definitely not suited for securely holding the vinyl hinges or pivot wires.

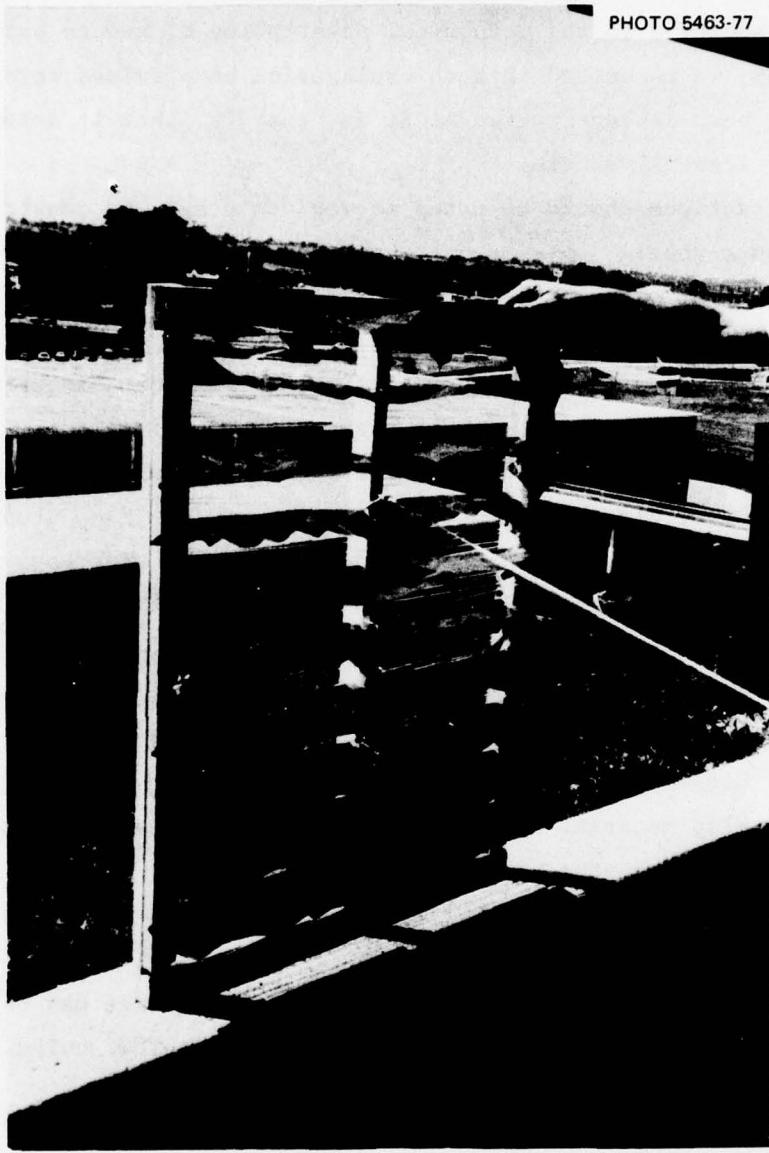
PHOTO 5463-77

Fig. 4.39. This is a properly constructed air pump which conforms to the measurements and use of materials specified in the two-page instructions.
